LOCATION 1119 Sunshine Uniform - Jenkins Rd. CITY OASTONIA  
BETWEEN Poplar St. STREET & Jenkins Rd. STREET

SIZE	TYPE	LENGTH	INSTALLED	RETIRED	RENEWED
MAIN TO BLDG.	2"	CFW	30'	9-27-94		
MAIN TO PROP. LINE						
PROP. LINE TO BLDG.

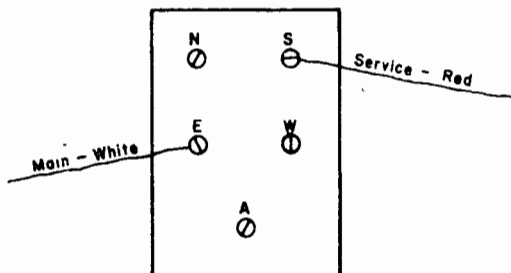
REMARKS: 143 - Form Attached. Removed 30' 2" CFW Pipe & Replaced with New 2" CFW Pipe - Installed Split Fitting & stopped line off until Tank Removal & Grading Complete. Then Reinstalled Pipe. Tested 2" CFW Service Pipe 15 min. Before Installings. Pipe badly pitted where coating had been knocked off previously when concrete pithers poured
